National Public Adjusting

Insured: Cole & Ashcroft, L.P.
Business: 5631 Brystone Drive
Houston, TX 77041

Price List: TXHO8X_JUL19
Restoration/Service/Remodel
Estimate: COLE&ASHCROFT

**DEFENDANT'S
EXHIBIT F**

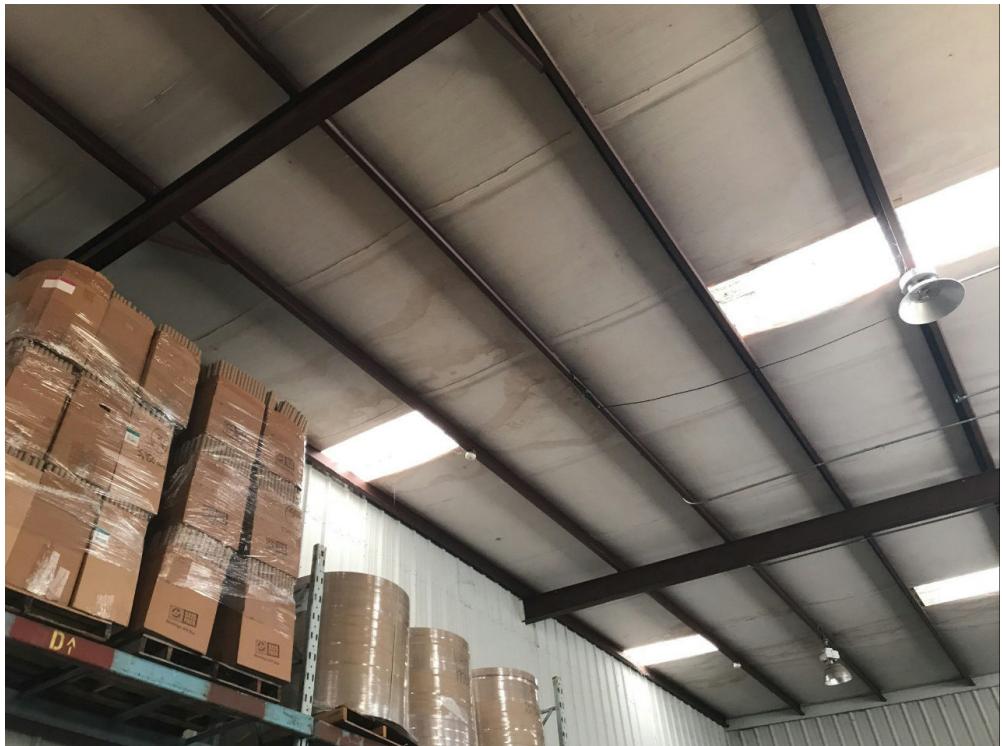
157 157-Ceiling Insulation Is Water Stained On The Roof Covering

This is the same roof covering that the engineer did not include in his report.

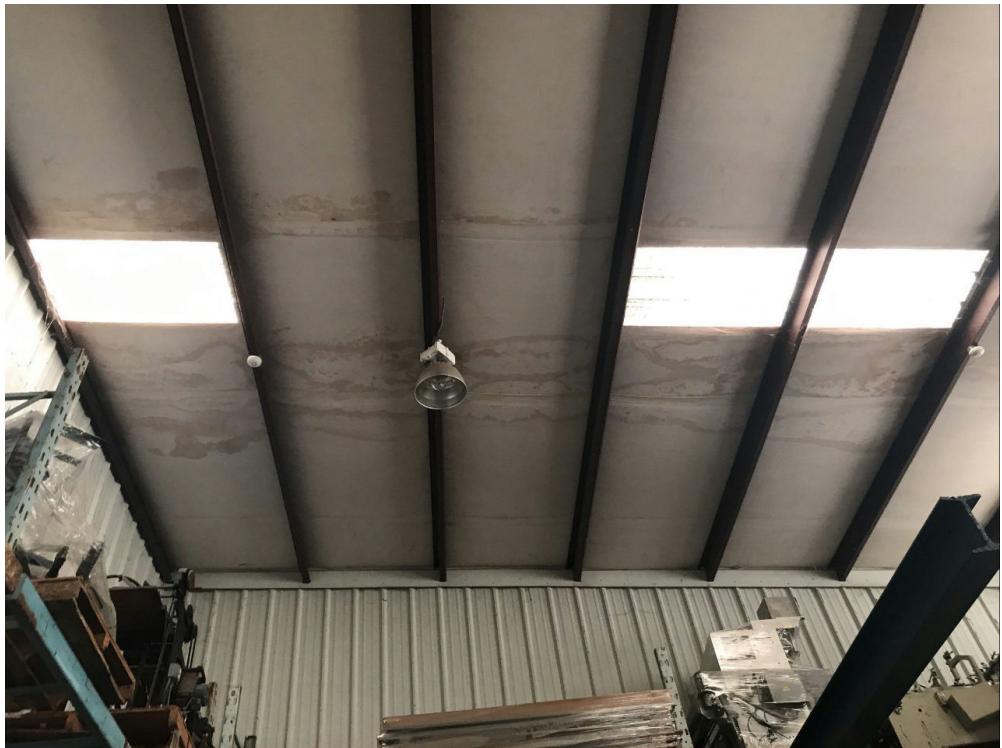
158 158-Warehouse Ceiling Overview

Tremendous amounts of water stained insulation.
